SEVENTH SEMI-ANNUAL STATUS REPORT
VOLUME II - APPENDIX A

ENERGY EFFICIENT ENGINE
COMPONENT DEVELOPMENT AND INTEGRATION PROGRAM

**ENERGY EFFICIENT ENGINE
HOLLOW FAN BLADES**

FINAL TECHNICAL REPORT

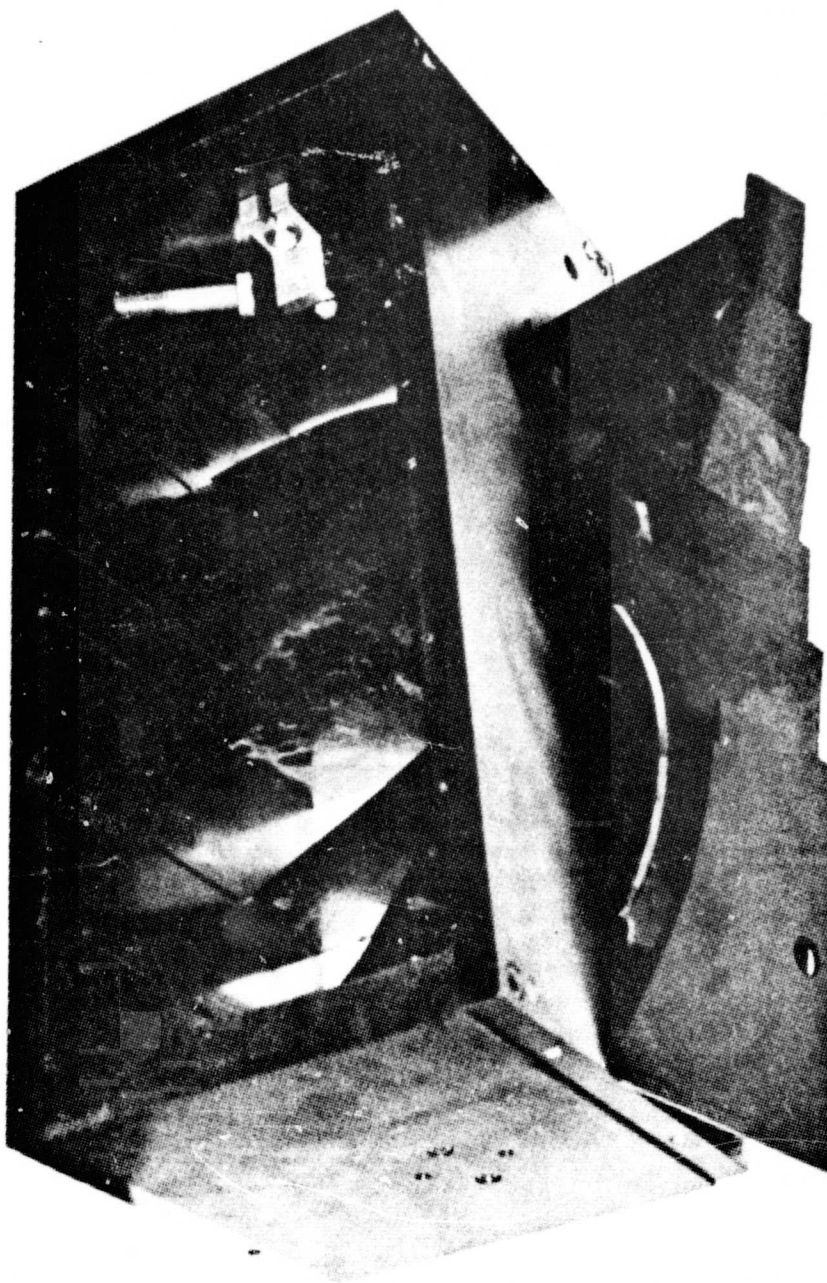
Figure 25. Blade Inspection Fixture and Templates.

TRW designed and built a blade inspection fixture. The fixture shown in Figure 25 locates off the root and tip locator of the final isothermally forged blade. The fixture allows inspection of the blade at six sections.

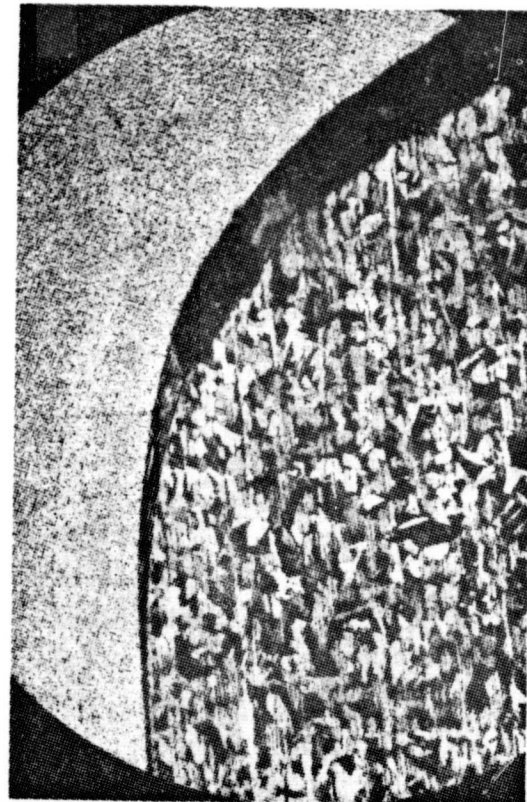
a. Typical 100X

b. TE Radius 30X

c. Core End 30X

d. Root Radius 30X

Figure 45. Typical Microstructures in DS2 at Several Areas.

The lack of a total bond in the specimen is related to the can failure (leak) during the first HIP run. Apparently some bonding was achieved between the laminates, but the leak caused the entrapment of argon gas used in HIP. The argon remained during the second HIP run causing the poor bonds. An example of voids at the bond lines of the laminates is shown in Figure 45(a). This section corresponds to the defective area noted in the Figure 44 (C-scan). Other areas of the diamond specimens also had voids present at the bond lines, but in most cases not as many as shown in Figure 45(a).

Several observations were to be made from this diamond specimen. The specimen was expected to provide information on the flow of the steel cores with respect to the titanium laminate at the hot isostatic pressing conditions. Specimen DS2 also had laminated root blocks, but without an airfoil-to-root radius. The surface condition of the cores was also to be evaluated as machined, polished on abrasive paper, or wrapped in 0.002-inch Ti 6Al-4V foil. Due to the lack of bonding at the core/laminate interface conclusions with respect to the effects of different core surface conditions could not be made. Figures 45(b) and 45(c) indicate that straight cut titanium core plies flow and form around the mild steel cores without causing core deformation. The radius at the root/airfoil interface was also found to be quite smooth conforming to the can radius as shown in Figure 45(d). In the initial layout a ninety degree angle was present at the root/airfoil interface.

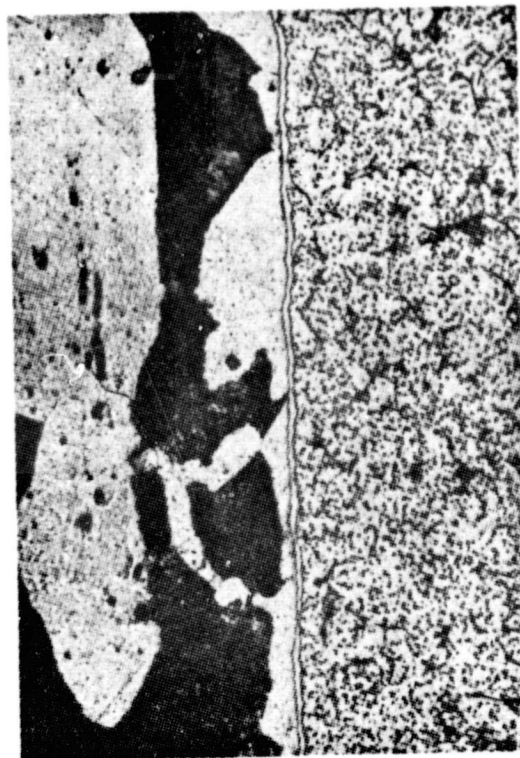
a. Trailing Edge (0.062-Inch Radius) 30X

b. Void Present at Leading Edge 30X

c. Crack Observed at Leading Edge 30X

Figure 49. Interface Between Valve Steel Core (TRW VMS-478) and the Titanium Laminates.

Three different cores and/or core materials were evaluated: TRW VMS-478 valve steel with a 0.062-inch trailing edge radius and 1045 steel with either a 0.015-inch or a 0.062-inch trailing edge radius. Metallographic results indicated that the valve steel core gave better cavity definition than the mild steel cores; however, some cracks and a lack of debulking were observed in the laminates near the core. Examples are shown in Figure 49. The crack observed in the titanium at the leading edge of the core has been attributed to the larger difference in thermal expansion between the titanium and valve steel than between the titanium and mild steel. The mean coefficients of thermal expansion (inch/inch/^oF) from room temperature to 1200^oF for these materials are 9.90 for Ti 6Al-4V, 14.7 for 1045 steel and 18.2 for TRW VMS-478 steel. Cracks were not observed in diamond specimens previously fabricated with 1045 steel cores. In addition, a reaction zone (see Figure 49(d), which probably contributed to the crack initiation, was observed at the titanium-valve steel interface. Good definition of the trailing edge for both the 0.062 and 0.015-inch radius 1045 steel cores was observed. Examples of 0.062-inch radius have been shown previously; the 0.015-inch radius is shown in Figure 50. Some waviness at the interface was present due to some local core deformation. There also appeared to be some bending of the core at the trailing edge for the 0.015-inch radius core which has been attributed to the non-uniform pressure distribution caused by a double canning approach.

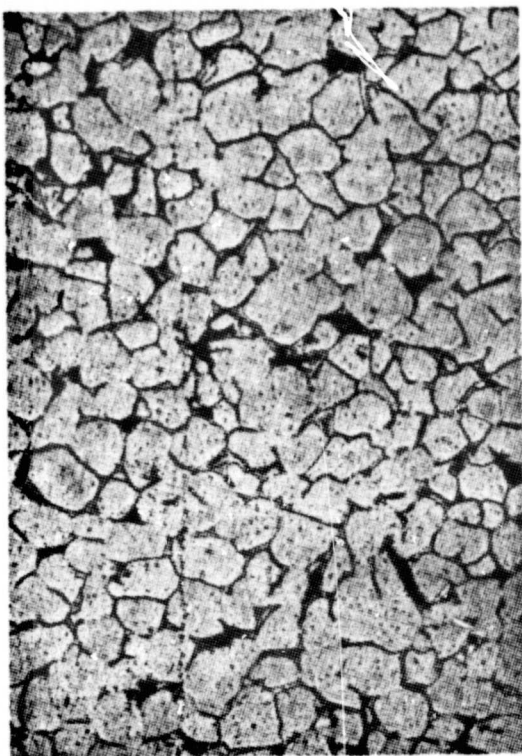
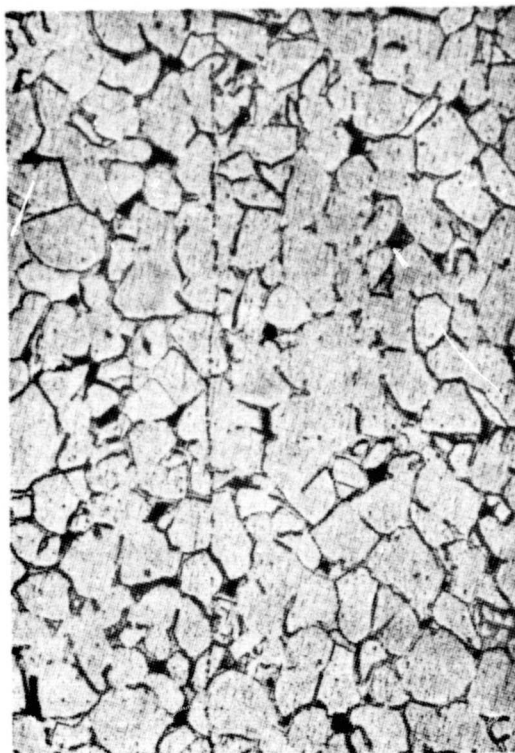
Figure 57. Typical Microstructure in DS 7 at Several Areas. Bond Lines Are Evident.

Metallographic evaluations of DS7 indicated good bonds were achieved; however, there was still evidence of some indications at the bond lines (see Figure 57). SEM analysis at P&WA has indicated that these indications are very small voids which they believe are probably attributable to argon. At the same time TRW reviewed the entire procedure of diamond specimen assembly and compared this process with previous efforts in titanium bonding. The only difference noted was that previous bonding was conducted under a dynamic vacuum while the current HIP is done in a static vacuum (sealed can). Since the cans are TIG welded in an argon atmosphere and mass spectrometer leak checked using helium, some adsorption of these gases is possible. The final sealing by electron beam (EB) welding would not be expected to allow removal of all of these gases.

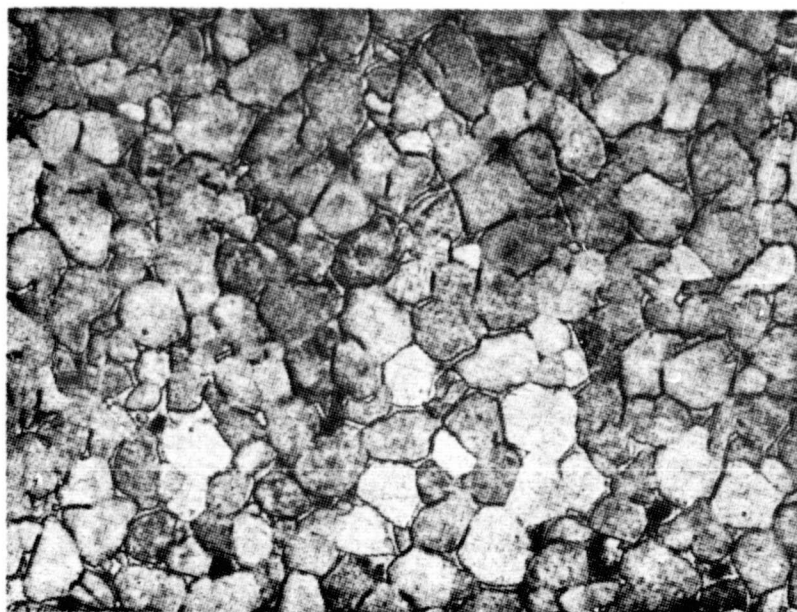
Figure 63. Microstructure in DS 8 at Several Areas. Etchant 96 H₂O-2HNO₃-2HF.

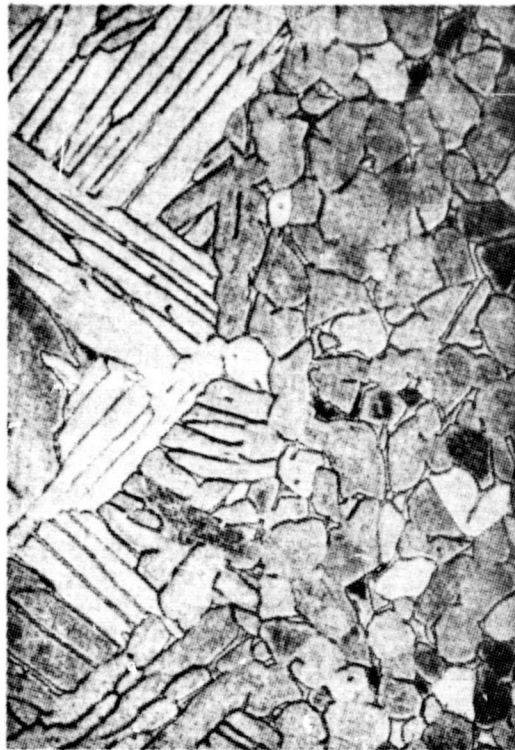
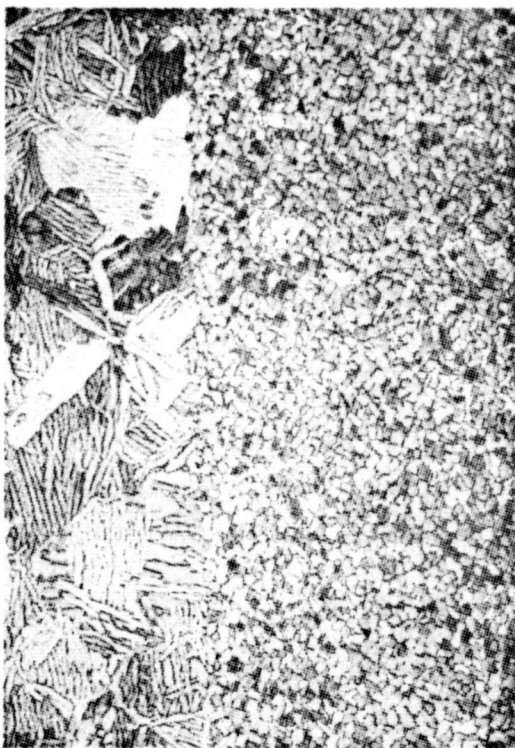
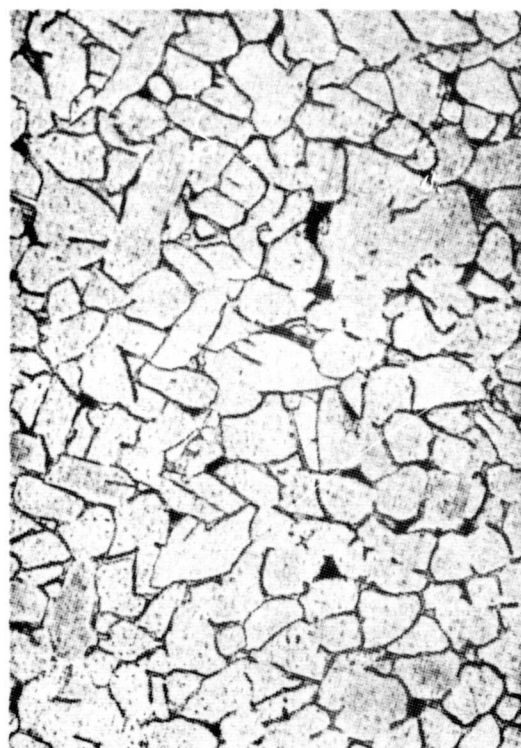
Figure 65. Typical Microstructure in DS 9 at Several Areas.

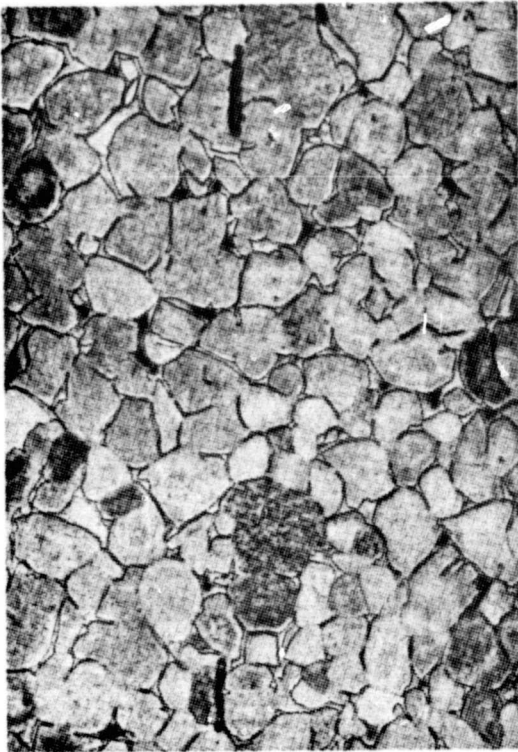
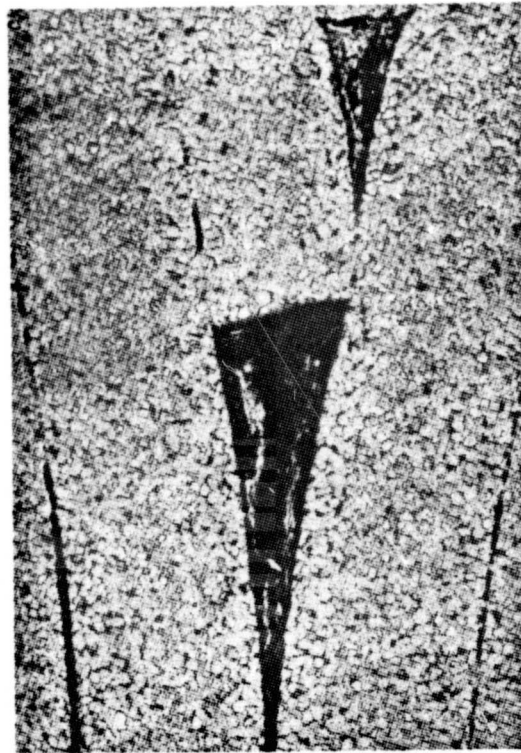
Figure 66. Typical Microstructures in DS10 at Several Areas.

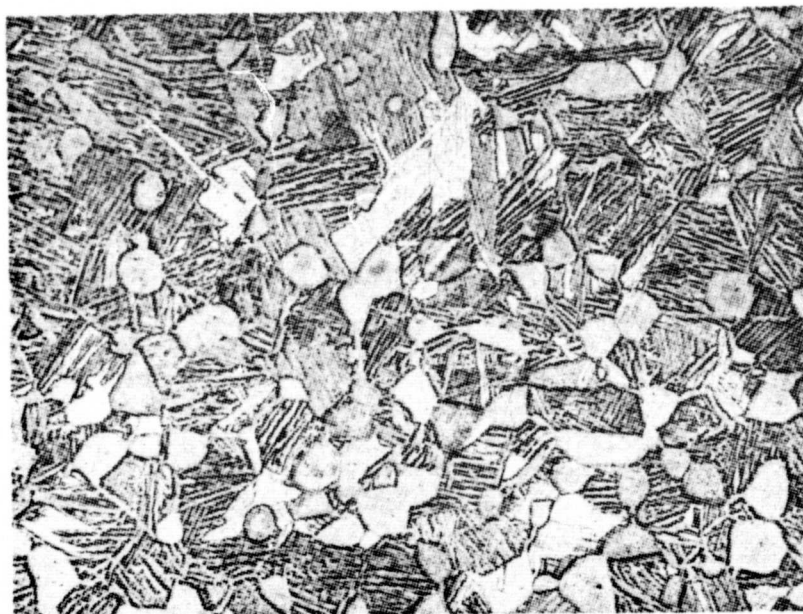
Figure 73. Typical Microstructure Along Edge in DS 25.
Etchant: $96\text{H}_2\text{O}-2\text{HNO}_3-2\text{HF}$.

DS25 was evaluated by X-ray, C-scan and metallography. X-ray and C-scan indicated a well-bonded specimen with the proper core registry. The results are shown in Figures 71 and 72. Metallographic evaluations of some edge material indicated excellent bonding (see Figure 73) when using the conventional 96H₂O-2HNO₃-2HF etchant for titanium. A more aggressive etchant, 60H₂-35 HNO₃-5HF, revealed the "microporosity" observed at the bond line in other specimens when this etchant was used. This "microporosity" previously was attributed to adsorbed argon; however, this diamond specimen was not exposed to argon since it was seam welded in air.

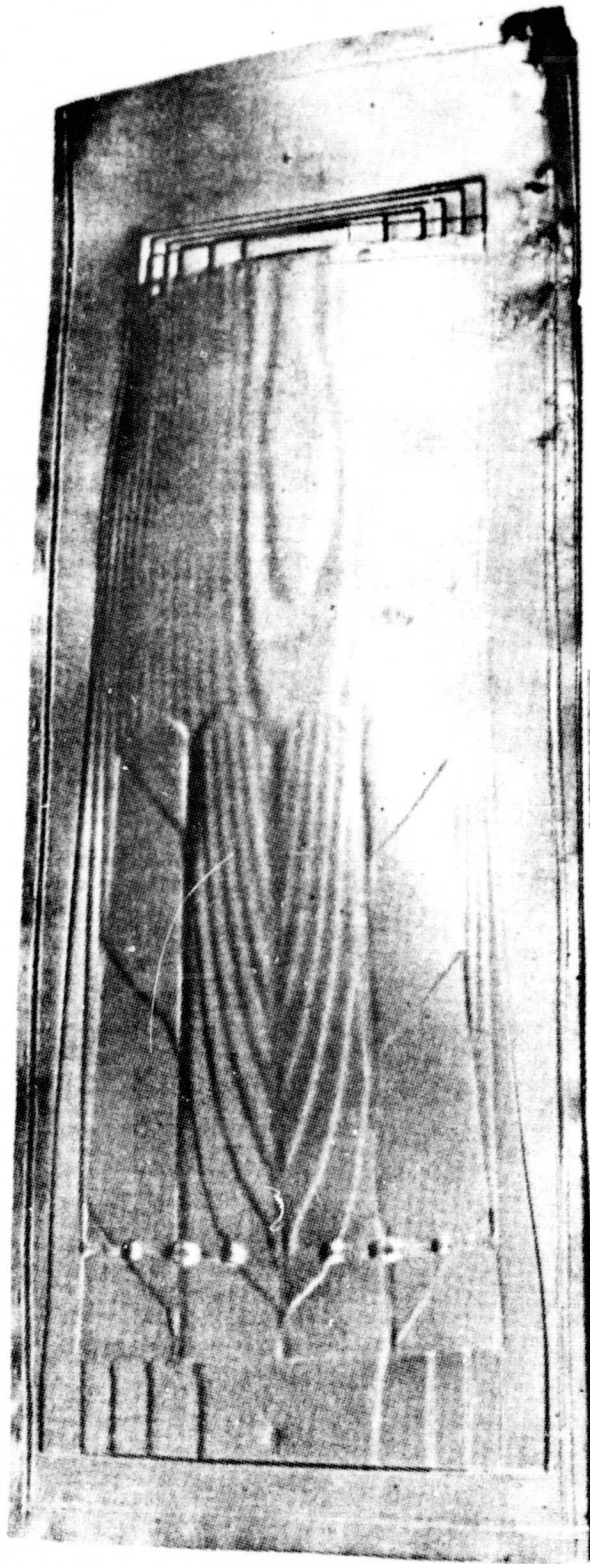
Figure 83. AS-HIP Blade 4.

The HIP cycle used at IMT was, again, the 4.5 hours at 1750°F temperature cycle previously used. Visual observations of both blades after HIP indicated that 4 appeared to be a good, well-bonded blade while 5 leaked during HIP. Blades 4 and 5 are shown after HIP in Figures 83 and 84. As shown in Figure 83, there is considerable surface detail due to ply endings, cores, etc. The blade also "rings" when tapped with a metallic object, which is an indication of bonding. X-rays of the blade indicated good core location with no evidence of ply endings (sharp lines in the X-ray film would indicate a lack of a good bond). However, there does appear to be some deformation of the "pins" located at the edge of the cores. The Figure 85 X-ray indicates these observations. These "pins" were added for passageways for acid core leaching. There appears also to be a relationship between the "pins" and "bumps" on the surface as shown in Figure 83. The bumps are excess titanium from the central plies.

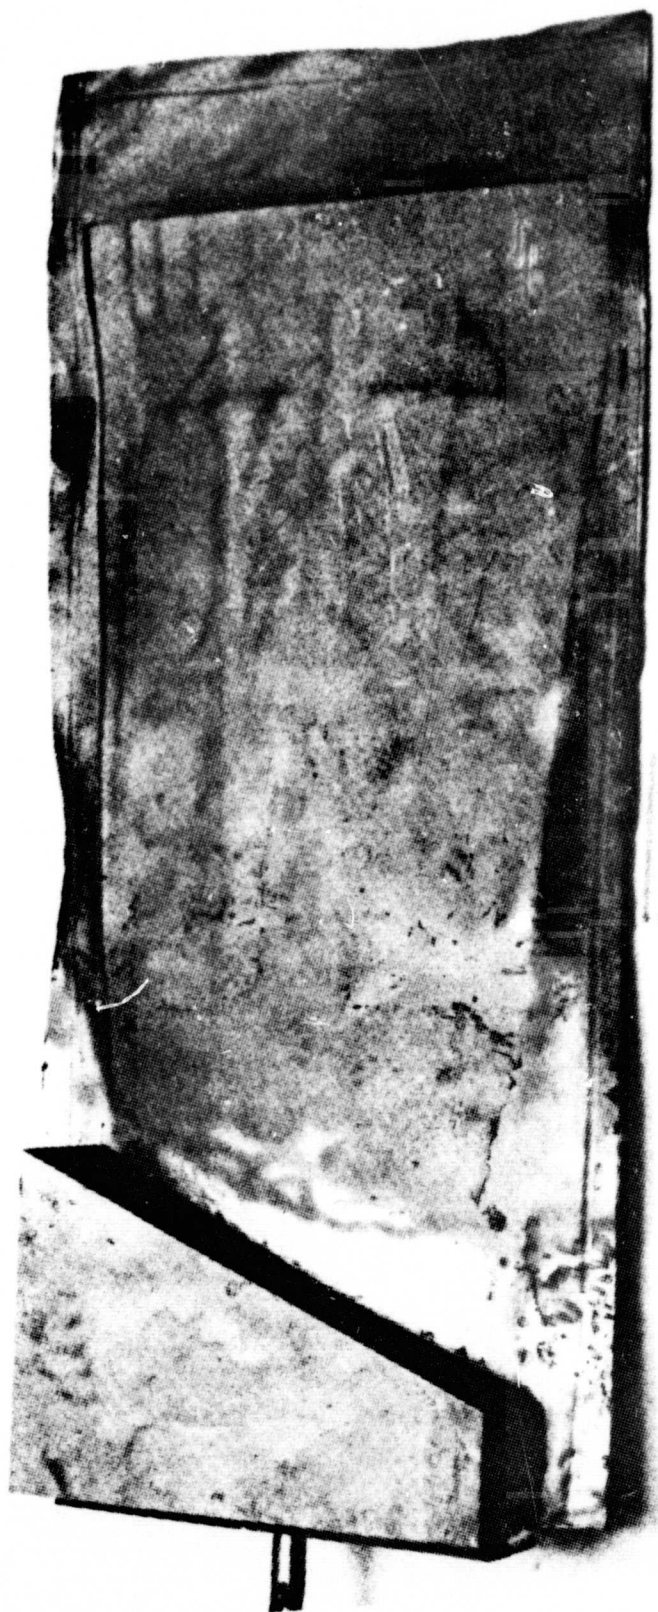
Figure 84. AS-HIP Blade 5.

Inspection of blade 5 with the root indicated leaks in several areas, the more prominent being in the canning sheet-root block interface towards the tip which were either seam or spot welded. Other leaks in the blade were observed, but found to be inconclusive due to lack of reproducibility. It appears that the leaks in the canning sheet-root interface were quite large leading to excessive helium in the area. This excessive helium discharge makes leak detection difficult. Based on the above observations, it appears that there was too much can collapsing in the canning sheet-root block area. High shear stresses and thin cover sheets contribute to these weld failures. It is doubtful that this canning approach can work with the current ply and root designs.

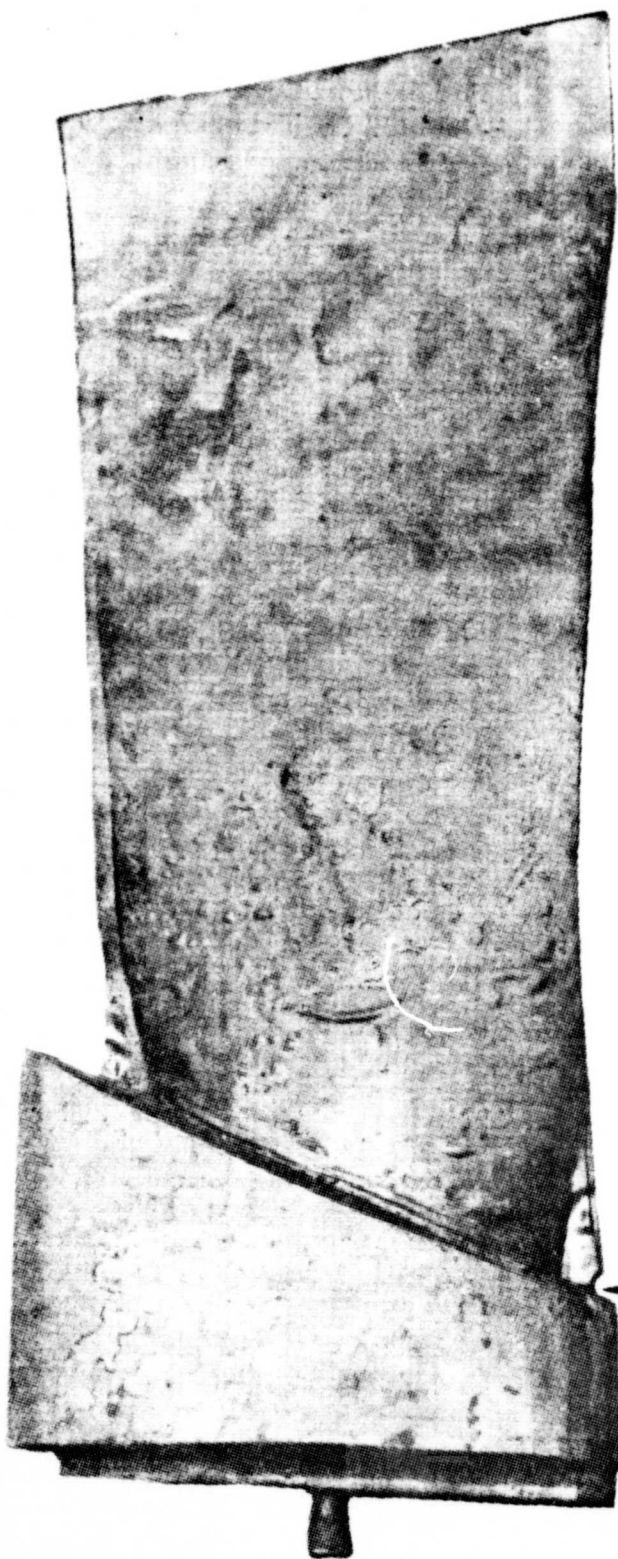
a. Cambered Blade

b. Airfoil Root Tearing

Figure 87. Blade 2 After Cambering.

Blade 2 is shown after cambering in Figure 87(a). Basically, the concept of cambering a flat blade layup after HIP appears very promising. There was some severe tearing observed at the leading and trailing edge areas of the airfoil-root interface as shown in Figure 87(b). The tearing occurred because the die and punch made contact with the airfoil prior to making contact with the root. Tooling rework was performed in this area.

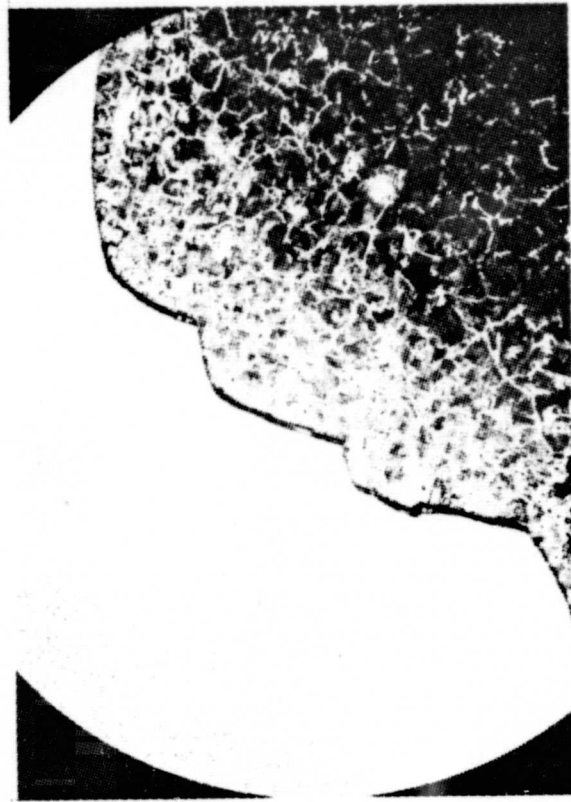
a. Connecting Pin Between Upper and Lower Core Sections

b. Area Between Upper and Lower Core Sections and Pins

Figure 99. Photomicrographs and Photomicrographs Illustrating Various Surface Conditions at the Core Edges for Blade 4.

c. Area Between Upper and Lower
Core Sections

Figure 99 is a series of photomacrographs and photomicrographs illustrating various surface conditions at the core edges for blade 4. Figure 99(a) shows that the connecting pin between the upper core section and lower core section experienced substantial deformation during HIP. The pin was deformed approximately 25%. This area is at the tip which saw no deformation during isothermal forging. Figure 99(b) shows an area through both core sections and the pin. While 99(c) shows an area between the two core sections. The nature of the steps indicates both core flow and ply indentation occurred during HIP. Figure 99(d) depicts a condition at the core end at the root. At this area it appears that rather severe core indentation occurred. Figure 99(e) and (f) are sections between cores (transverse sections) illustrating typical surface condition at the radii. These areas appeared to be more uniformly indented rather than a condition shown in 99(d) for the core end. Figure 99(g) shows the condition at the edge of a core at the blade edge. Figures 99(d) through (g) are from a heavily deformed area of blade 4. For all the sections evaluated there was no evidence of voids due to lack of fill. The gaps shown in Figure 99 between core and HIP laminates are the result of shrinkage during cooling. One of the obvious conclusions from the above series of photomicrographs was that core indentation was more severe for the blades than it was for the diamond specimens. In order to solve this problem a stronger core material will have to be used, but one that has a better thermal expansion match than the TRW VMS-478 alloy in order to prevent crack problems due to high stress conditions.

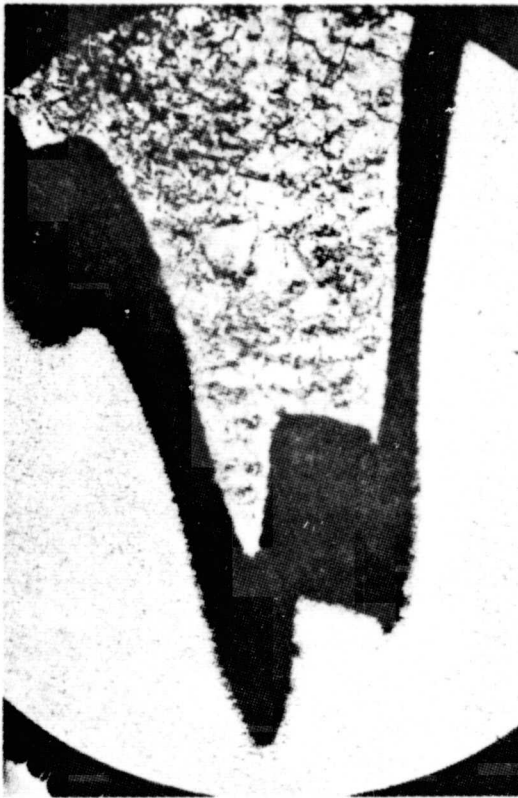
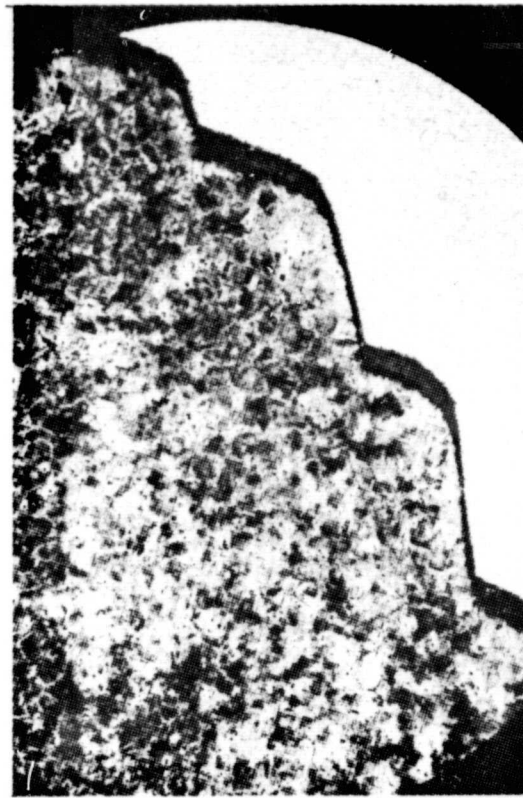
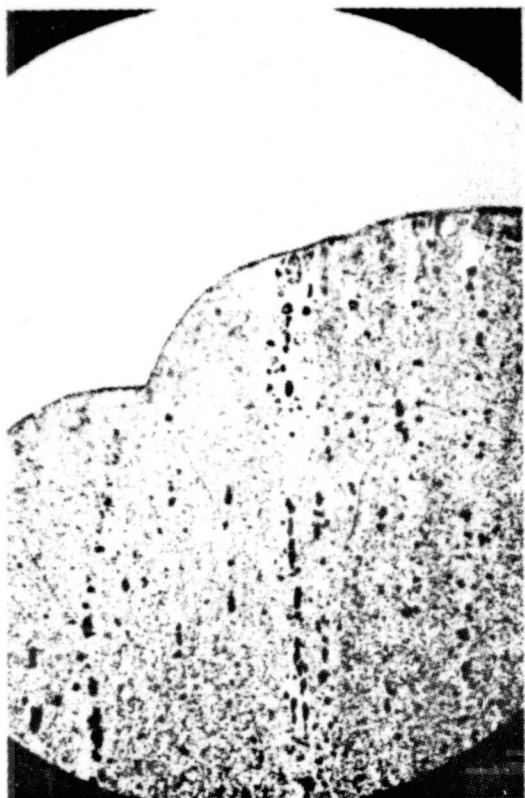
d. Core Root End Cross Section

e. Surface Condition Between Cores

Figure 99. (cont'd) Photomicrographs and Photomicrographs Illustrating Various Surface Conditions at the Core Edges for Blade 4.

f. Surface Condition Between Cores

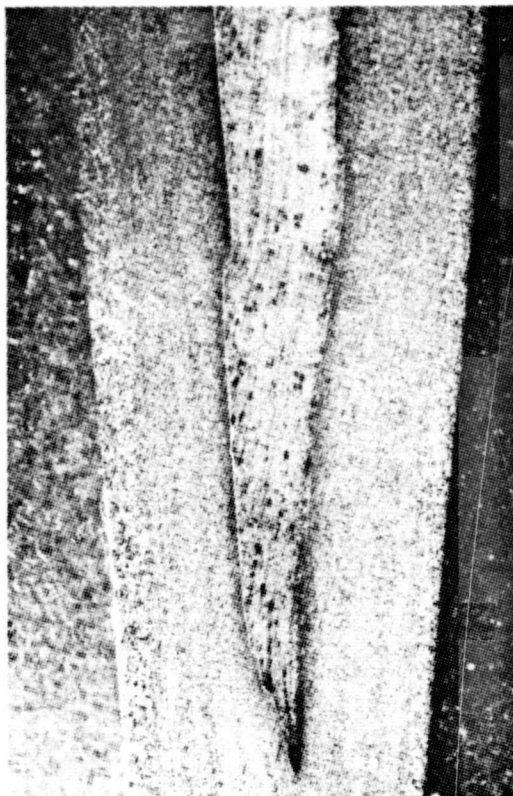
g. Leading/Trailing Edge Core Condition

Figure 99. (cont'd) Photomicrographs and Photomicrographs Illustrating Various Surface Conditions at the Core Edges for Blade 4.

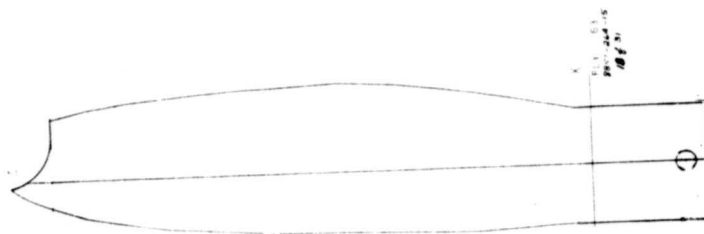
Figure 103. (cont'd) Ply Designs.

X
PLY 88
PART - 244 - 15
06 of 01

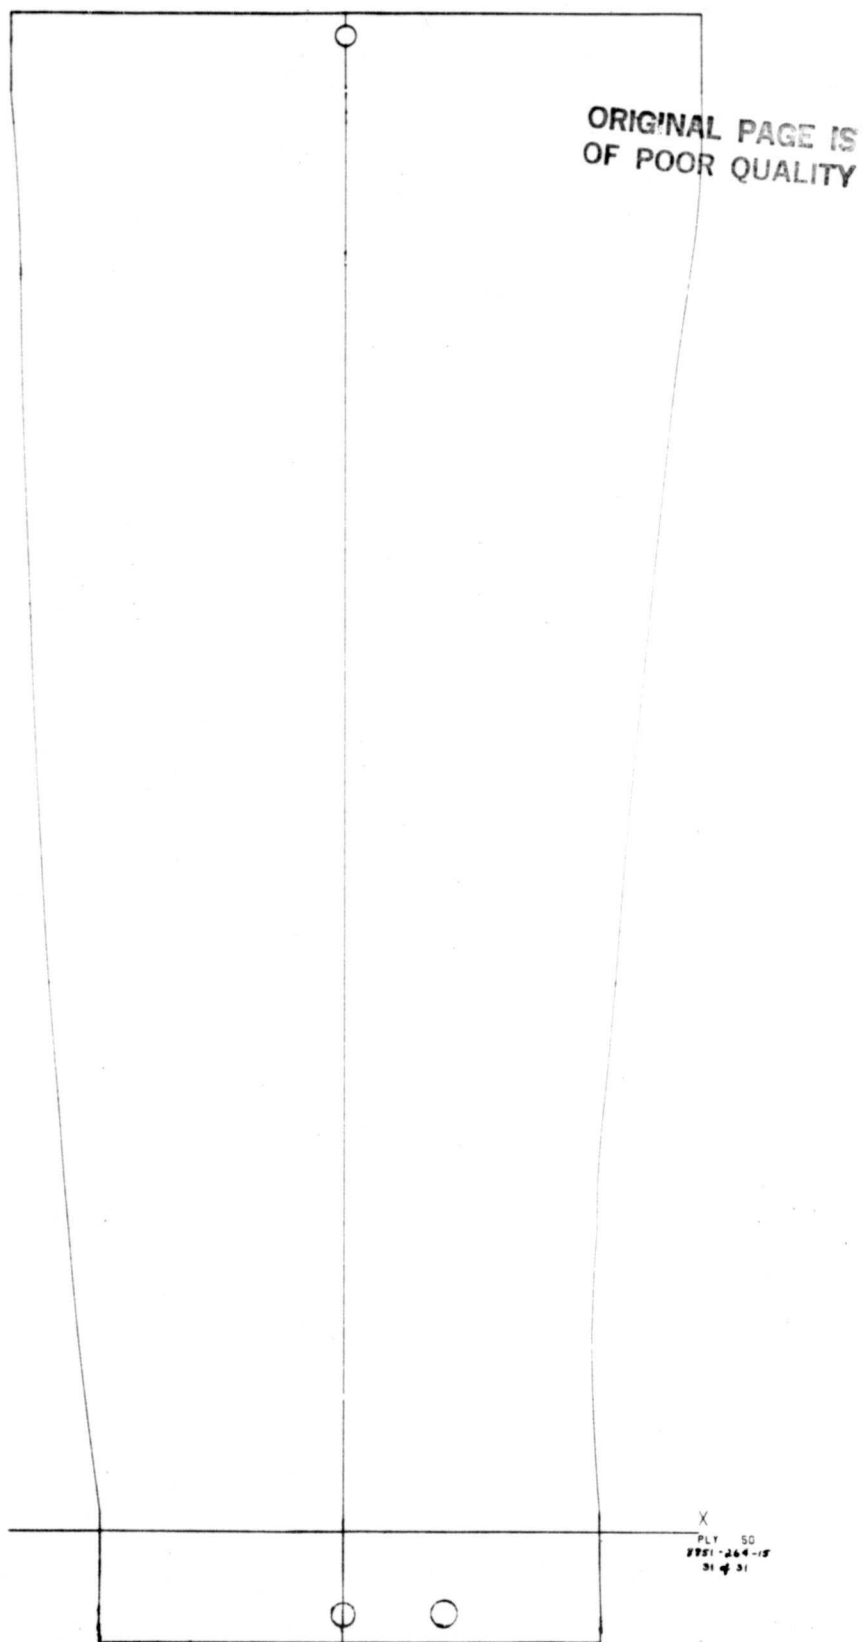
Figure 103. (cont'd) Ply Designs.

X
PLY 51
2261-244-15
30 of 31
